Manhole Inspection Summary

Manhole # S61A1_005MH

Insp Date: **12/18/08 3:26 PM**

Location Address: **5001 Keith Ave.**

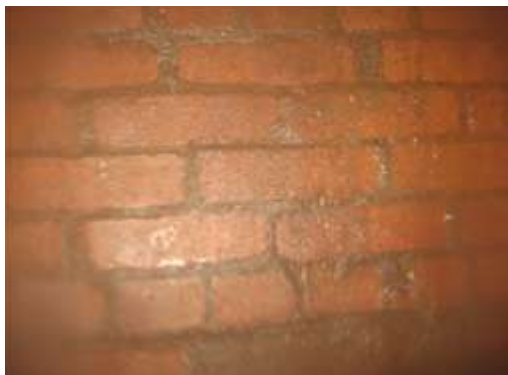
Defect 4

wall infiltration

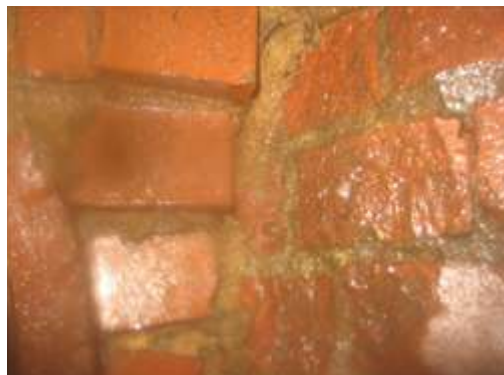
Defect 1

wall infiltration

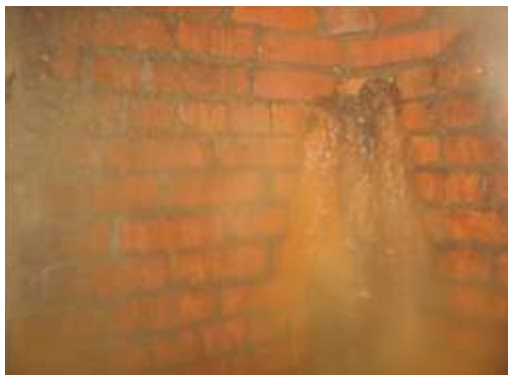
Defect 2

wall infiltration and encrustation

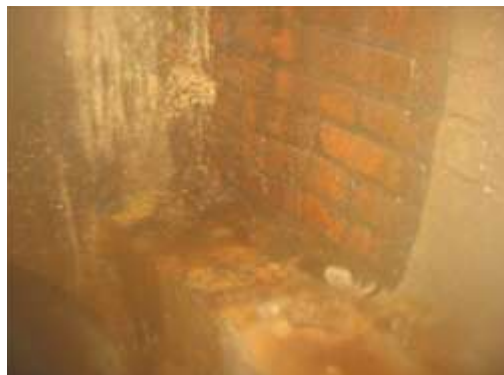
Defect 3

Infiltration evidence at bench/barrel

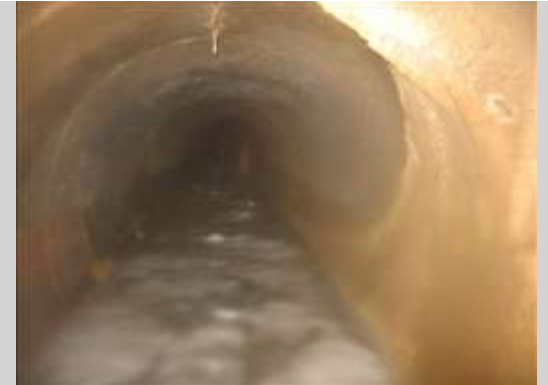
12 O'Clock Outflow

Pipe Height: **42** (in.) Rod and Bar (Angled)
Pipe Material: **Concrete** ☐ Pipe Lined
Invert Depth: **30.33** (ft.) Flow Characteristics: **Slow**
Deposits: ☐ None ☐ Mud ☒ **Sludge** ☐ Debris ☐ Grease
Silt Depth: **0.25** (in.) Deposits Extent: **Light**
Infiltration: **None** Pipe Seal Cond: **Sound**

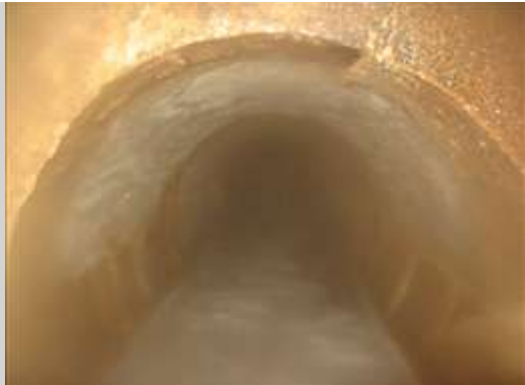
6 O'Clock Inflow

Deposits: ☐ None ☐ Mud ☒ **Sludge** ☐ Debris ☐ Grease

Silt Depth: **0.25** (in.) Deposits Extent: **Light**
